The Emfuleni Water Loss Project – A major challenge

Authors : WA Wegelin*, RS Mckenzie*, B van der Merwe**, M Maboyja**

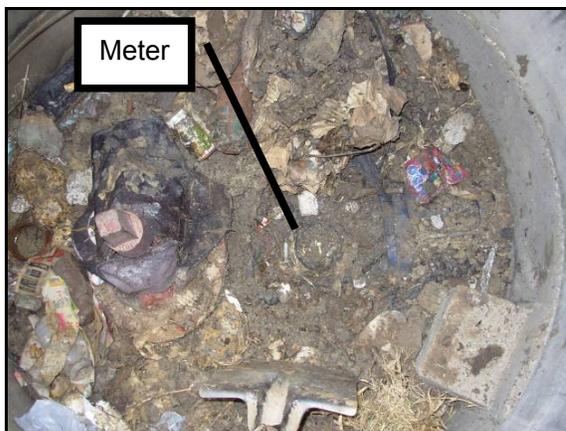
Figure 1: Dirty Meter Chamber

Due to the current lack of skilled human resources within the municipality, it was decided not to set-up dedicated leak detection teams. Instead, three contractors were appointed to clean water supply infrastructure and report on any visible leaks found. Their brief was as follows:

- Locate water infrastructure such as isolating valves, hydrants and meter boxes as indicated on drawings;
- Clean the inside of boxes and chambers;
- Clean the area around boxes and chambers to clearly expose it;
- Mark missing infrastructure on maps;
- Record leaks and report back to the client for repairs;
- Ascertain the condition of municipal water infrastructure;
- Generate employment; and
- Improve the level of service to each individual customer.

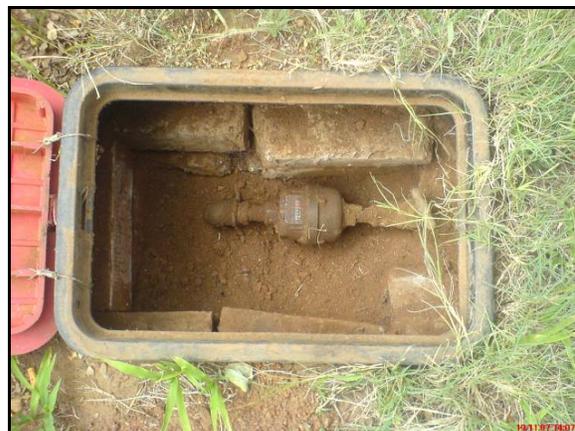
Figure 2 Cleaned meter box

- 11 248 Consumer meters, valve and hydrant boxes were located and cleaned;
- Consumer meters can now be read;
- Approximately 544 visible leaks were detected through the process and reported to the Municipality;
- Local emerging contractors were awarded meter cleaning contracts and generated substantial employment through the exercise.

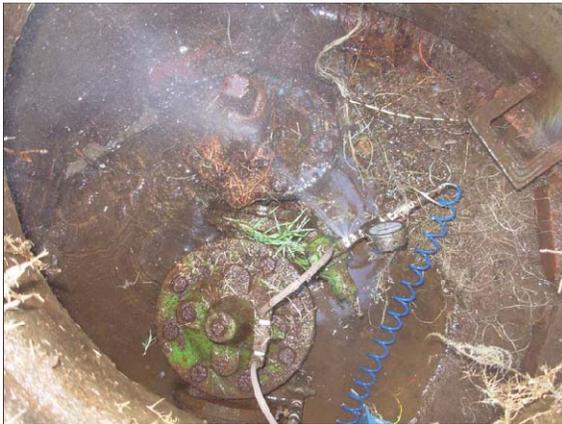
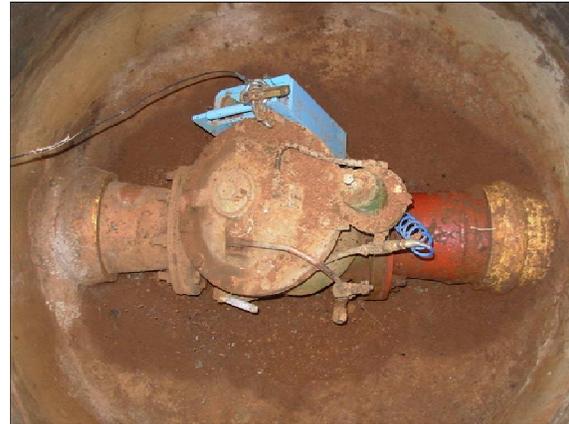
Figure 3: Pressure reducing valve installations prior to refurbishment

The first pressure management task was to service all the existing PRV's in the system, standardise the pipework (pipe rail and pilot) and secure the chambers. In addition, 15 smart controllers were installed on key PRVs to reduce the pressures during off peak demands. Furthermore, GSM pressure loggers were installed at critical points through out the system to monitor pressures at these points. Approximately 45 pressure-reducing valves were refurbished and are currently in the process of being commissioned.

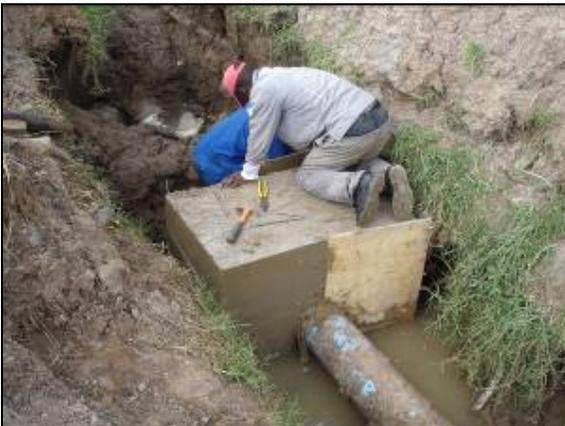
Figure 4: Thrust block to anchor pipeline

The municipality identified a 300mm river crossing in Small farms, which had been washed away on numerous occasions, as an urgent reticulation upgrade that was required. This is an example of several reticulation upgrades in the area to improve the level of service.

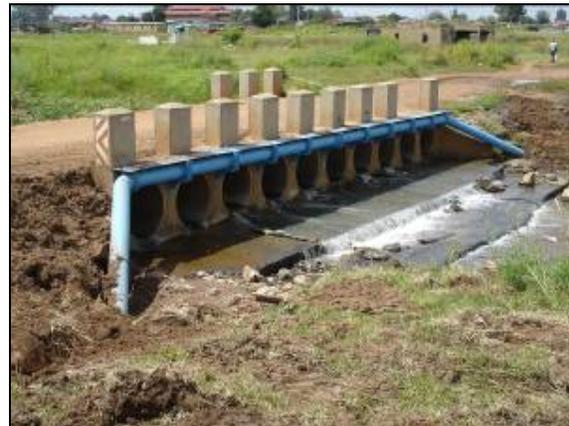
Figure 5: River crossing Completed

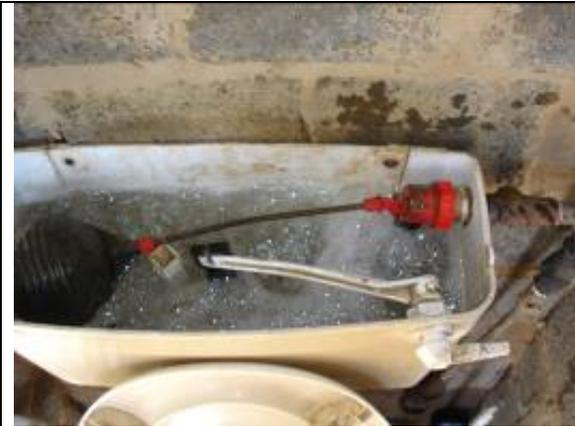
Figure 6: Cistern running permanently

Once the bulk supply and reticulation problems were resolved, the pressures stabilised at the expected pressures and it was possible to implement pressure management. The results from each intervention were properly recorded and shown in **Figure 8**. Each household was visited by the project team as part of the community awareness intervention programme. During this exercise, it was found that more than 80% of the households have internal leakage problems.

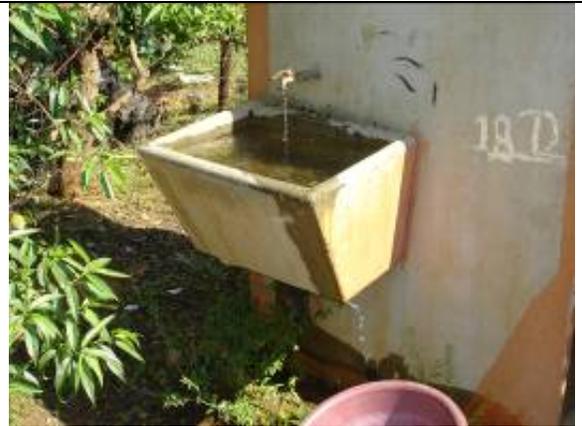
Figure 7: Tap running permanently
